**DEPARTMENT OF TRANSPORTATION**

Contract #: 04-0120F4Cty: SF/ALA Rte: 80 PM: 13.2/13.9File #: 69.28**WELDING INSPECTION REPORT****Resident Engineer:** Siegenthaler, Peter**Address:** 333 Burma Road**City:** Oakland, CA 94607**Report No:** WIR-018967**Date Inspected:** 16-Dec-2010**Project Name:** SAS Superstructure**OSM Arrival Time:** 700**Prime Contractor:** American Bridge/Fluor Enterprises, a JV**OSM Departure Time:** 1900**Contractor:** Zhenhua Port Machinery Company, Ltd (ZPMC), Changxing Island **Location:** Shanghai, China**CWI Name:** Zhu Feng**CWI Present:** Yes No**Inspected CWI report:** Yes No N/A**Rod Oven in Use:** Yes No N/A**Electrode to specification:** Yes No N/A**Weld Procedures Followed:** Yes No N/A**Qualified Welders:** Yes No N/A**Verified Joint Fit-up:** Yes No N/A**Approved Drawings:** Yes No N/A**Approved WPS:** Yes No N/A**Delayed / Cancelled:** Yes No N/A**Bridge No:** 34-0006**Component:** TOWER Components**Summary of Items Observed:**

**EAST TOWER – LIFT-5 COVER PLATE**

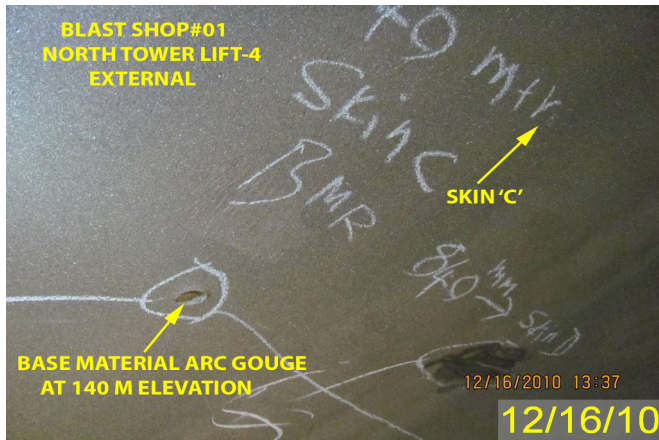
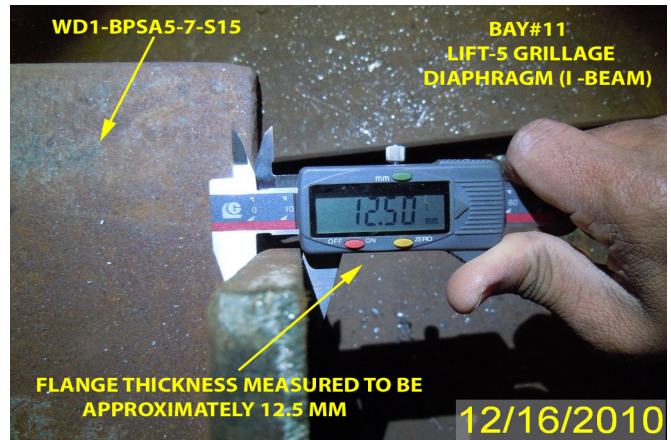
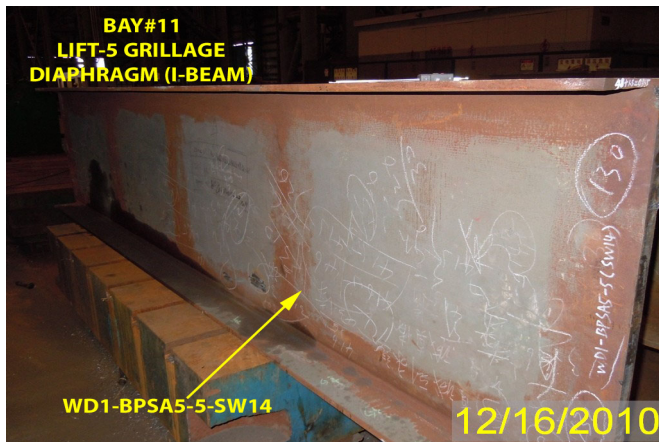
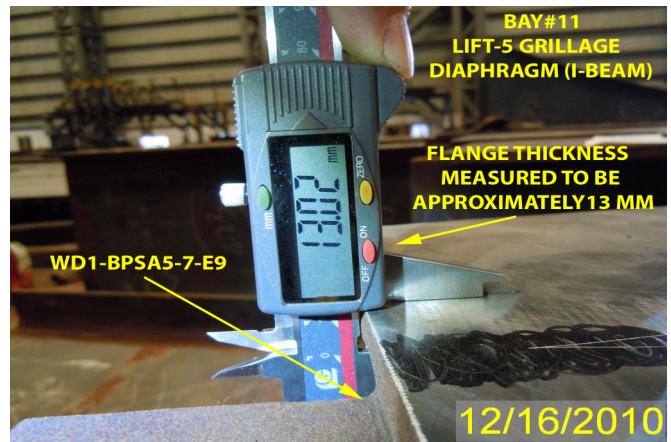
During the Caltrans Quality Assurance (QA) dimensional verification on Lift-5 tower grillage I-beams, this QA Inspector discovered the following issue:

-As per the reference 1384 R0 (Changxing daily dated 11-30-10), For 16 mm plate flanges: 14 mm minimum thickness is acceptable.

- Three (3) I-beam PL 16 mm flange thicknesses observed to be out of tolerance:

1. WD1-BPSA5-5-SW14 – measured thickness is 11.86 mm.
2. WD1-BPSA5-5-S15 – measured thickness is 12.50 mm.
3. WD1-BPSA5-7-E9 – measured thickness is 13.02 mm.

-The components are located at fabrication Bay#11.

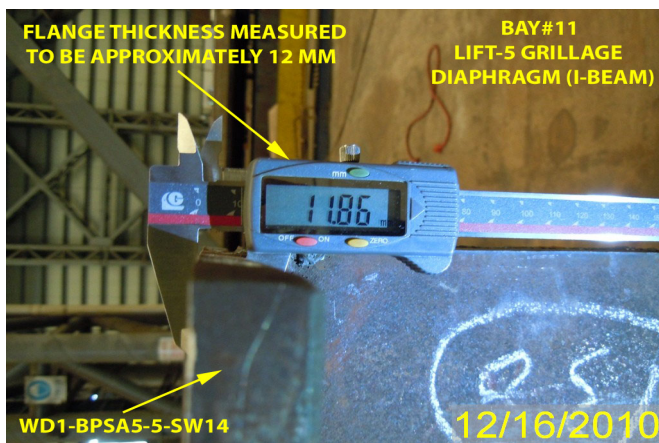
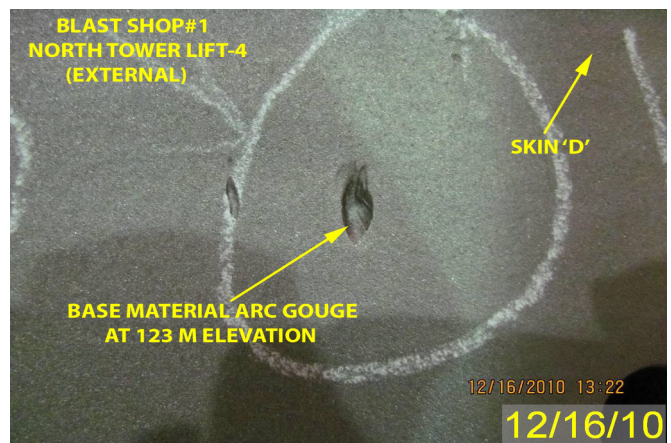
During the External post-blast visual inspection on North tower Lift-4, this Quality Assurance Inspector's (QA) discovered the defects required welding and Magnetic particle testing on weld and base material at the following locations:

1. Skin 'C' – Base material arc gouge – at 140 M elevation; 840 mm from C/D corner.
2. Skin 'D' – Base material arc gouge – at 123 M elevation; 720 mm from D/E corner.
